Group 6: Massey Draw – 2023

James Berntsen, Maddie Fox, Stella Hindman, Emma Leszczak, Jordan Munns, Alex Sobierajski

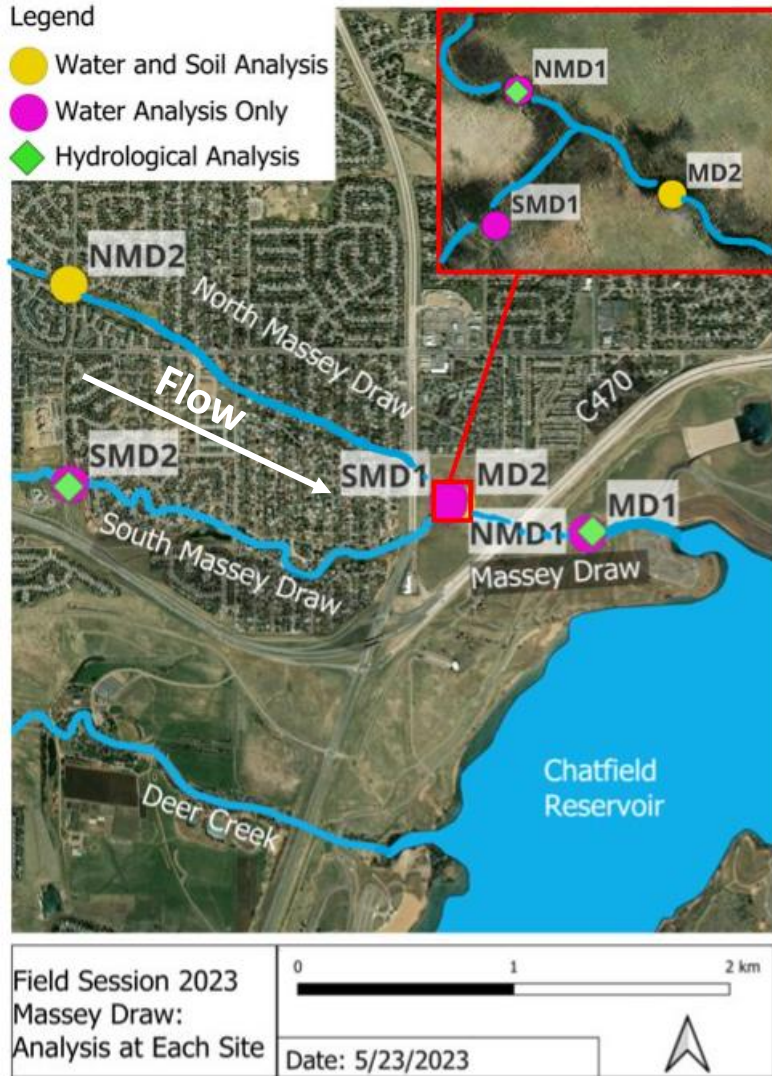
Figure 1. Site map

Table 1. Site information

Site ID	Latitude	Longitude	Site Description
MD1	39°33'31.13"N	105°4'23.86"W	East of Chatfield pedestrian footbridge
MD2	39°33'35.78"N	105°4'49.29"W	Confluence of North and South Massey Draw
NMD1	39°33'36.51"N	105°4'50.69"W	100 feet upstream of confluence on North Massey Draw
NMD2	39°34'8.68"N	105°6'4.57"W	West of Willow Creek residential area, south of the roundabout on Garrison Way
SMD1	39°33'35.56"N	105°4'50.89"W	100 feet upstream of confluence on South Massey Draw
SMD2	39°33'38.58"N	105°6'4.35"W	Surrounded by a pool, Falcon Bluffs middle school, and residential development
