Chatfield Watershed Authority

**Water Quality Assessment of the
“Massey Draw Watershed and Ecosystem Improvements Pilot Project”**

**And
Authority Proposed Expanded Post-Construction Monitoring Program**

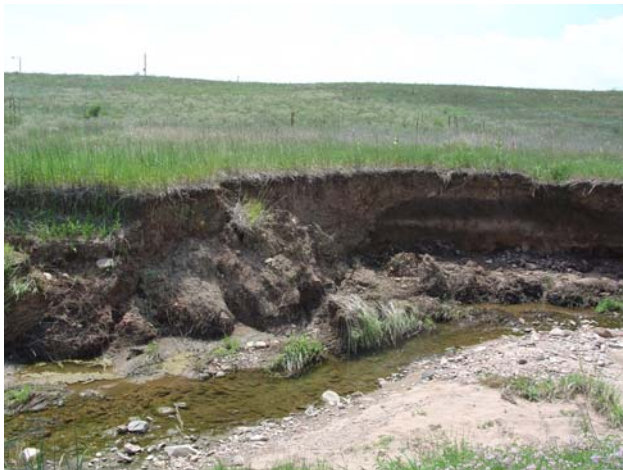
from 236 to 475 mg/l with an average concentration of 326 mg/l. Storm events in Massey Gulch can produce runoff of 100 cfs or more. A 100 cfs runoff event had the potential to generate about 88 tons of suspended sediment loads per day. The annual average stream flow is about 1.0 cfs with a 100-year event resulting in a flow over 3,500 cfs. Generally, the area experiences 2-4 larger runoff events per year. Typical suspended sediment loading from the gulch averaged 0.05 to 1 tons per day during more normal runoff. Without accounting for storm generated sediment load, Massey Draw typically produced 15 tons of suspended sediment loads per year. It is safe for the

Authority to estimate that the total suspended sediment load from Massey Draw generally exceeded 150 tons per year. This sediment loading is evident in Chatfield Reservoir where a large sediment delta formed at the discharge of Massey Draw into the reservoir. The pilot project was designed to reduce the peak storm event suspended sediment loading by eliminating major erosional sources (Table 1). On June 27, 2004, Massey Draw experienced a 10-year flood event that caused significant bank erosion and sediment transport. This was over a 100 cfs event as seen in the figure to the right.
