## Group 6: Massey Draw – 2023

Massey Draw:
Analysis at Each Site Date: 5/23/2023

Field Session 2023

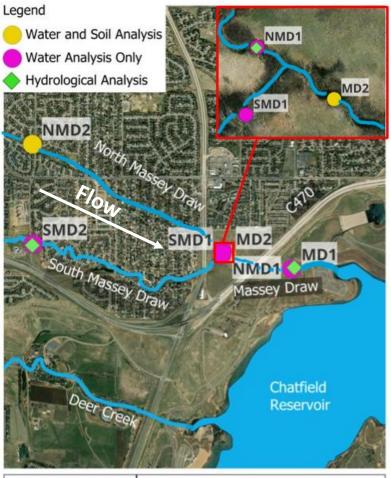
Figure 1. Site map

Site ID	Latitude	Longitude	Site Description				
MD1	39°33'31.13"N	105°4'23.86"W	East of Chatfield pedestrian footbridge				
MD2	39°33'35.78"N	105°4'49.29"W	Confluence of North and South Massey				
	39 33 33.76 N	103 4 49.29 W	Draw				
NMD1	39°33'36.51"N	105°4'50.69"W	100 feet upstream of confluence on North				
	29 22 20.21 IV	105 4 50.09 W	Massey Draw				
NMD2	39°34'8.68"N	105°6'4.57"W	West of Willow Creek residential area,				
	39 34 6.06 IN	103 0 4.37 W	south of the roundabout on Garrison Way				
SMD1	39°33'35.56"N	105°4'50.89"W	100 feet upstream of confluence on South				
	39 33 35.30 N	105 4 50.69 W	Massey Draw				
SMD2	39°33'38.58"N	105°6'4.35"W	Surrounded by a pool, Falcon Bluffs middle				
	33 33 30.30 IV	103 0 4.55 W	school, and residential development
